Moel Findeg Local Nature Reserve, Denbighshire

TOPOGRAPHICAL SURVEY

CPAT Report No 797

N W Jones
May 2006

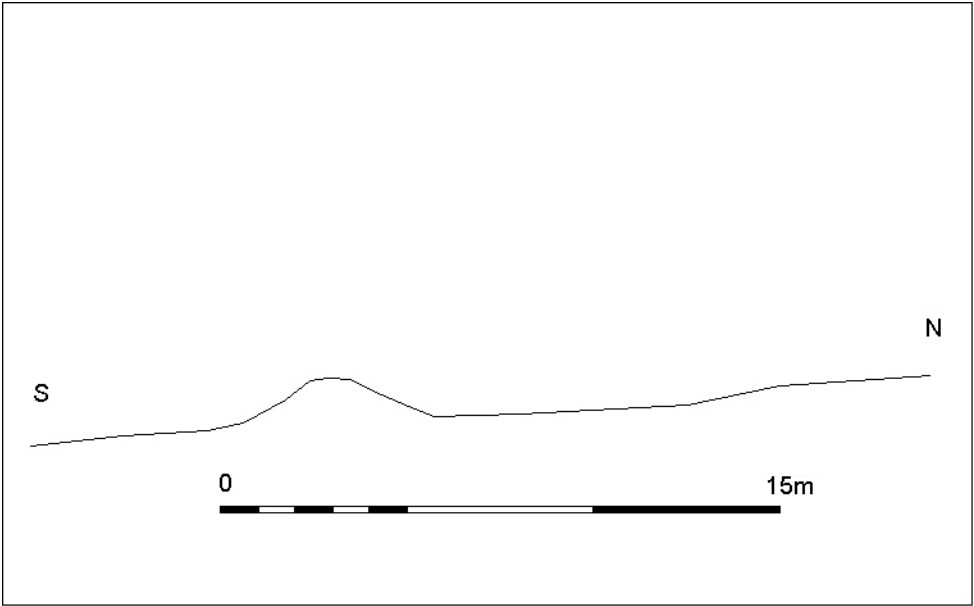
Fig. 4 Profile of pond PRN 80205

- 2.5 The survey also recorded a stone-revetted loading platform (PRN 80231) associated with a nearby quarry, and a collapsed mine shaft (PRN 80203).
- 2.6 Towards the southern corner of the Reserve a separate total station survey recorded the earthwork remains of a small reservoir (PRN 80205). This consisted of a retaining bank 55m long and up to 1.2m high and 4m wide which now has a substantial breach, presumably where the sluice was originally located. The reservoir was fed by a leat leading from a spring. Water from this reservoir would have been carried by a leat, which no longer traceable, to a reservoir beyond the boundaries of the Reserve, which itself supplied the series of reservoirs described above.
- 2.7 Some 35m to the north the survey also recorded what appears to be the infilled remains of a small shaft and spoil mound.

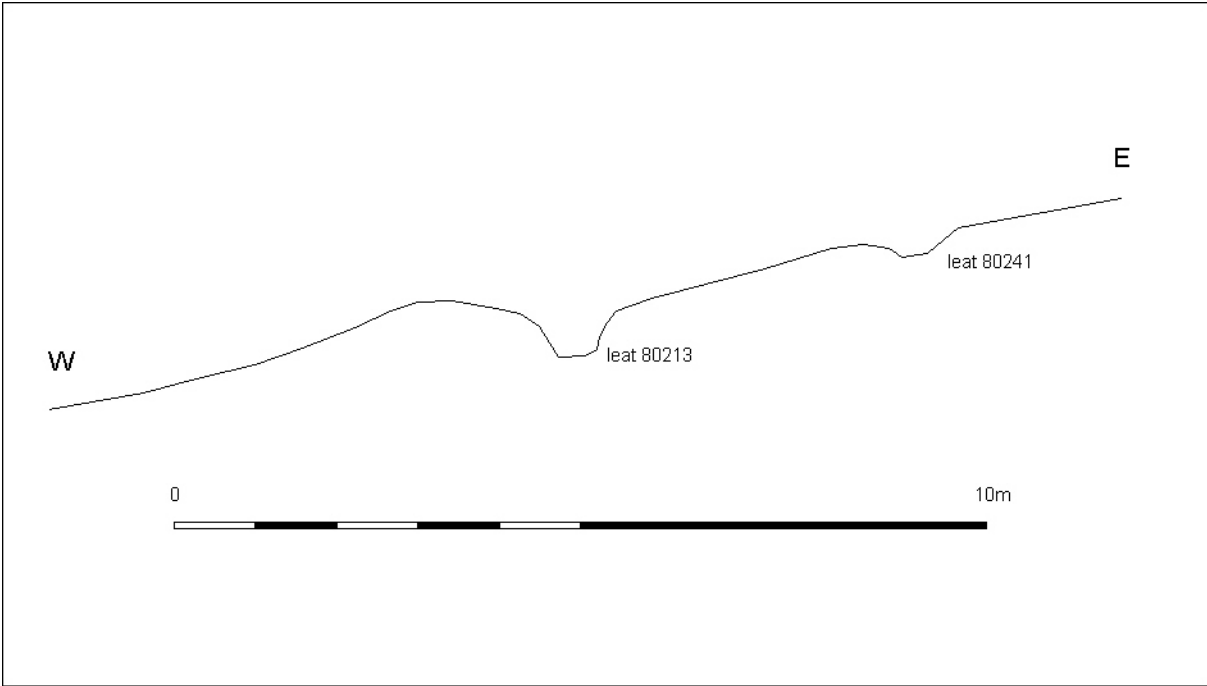
Fig. 5 Profile of leats PRN 80213 and 80241

- 2.4 The reservoirs were fed by a series of leats, of which the primary leat (PRN 80213) survives as a substantial earthwork which contours the hillside from the south. The leat was formed by an earthen bank up to 1.1m high and 4.5m wide on the upslope side of which was a channel 0.65m wide and up to 0.7m deep, the sides of which are in places near vertical, suggesting some form of revetment. The leat runs from south to north and originally carried water from a now silted reservoir 250m to the south-east, outside the boundaries of the Reserve. A series of leats, including PRNs 80233 and 80242 would have enabled the diversion of water to supply the main reservoir (PRN 80206). Immediately upslope of the primary leat is a further, shallow leat (PRN 80241), which does not appear to have been fed from a particular source but appears to have gathered surface water from the slope above and unusually slopes in either direction from the central high point.

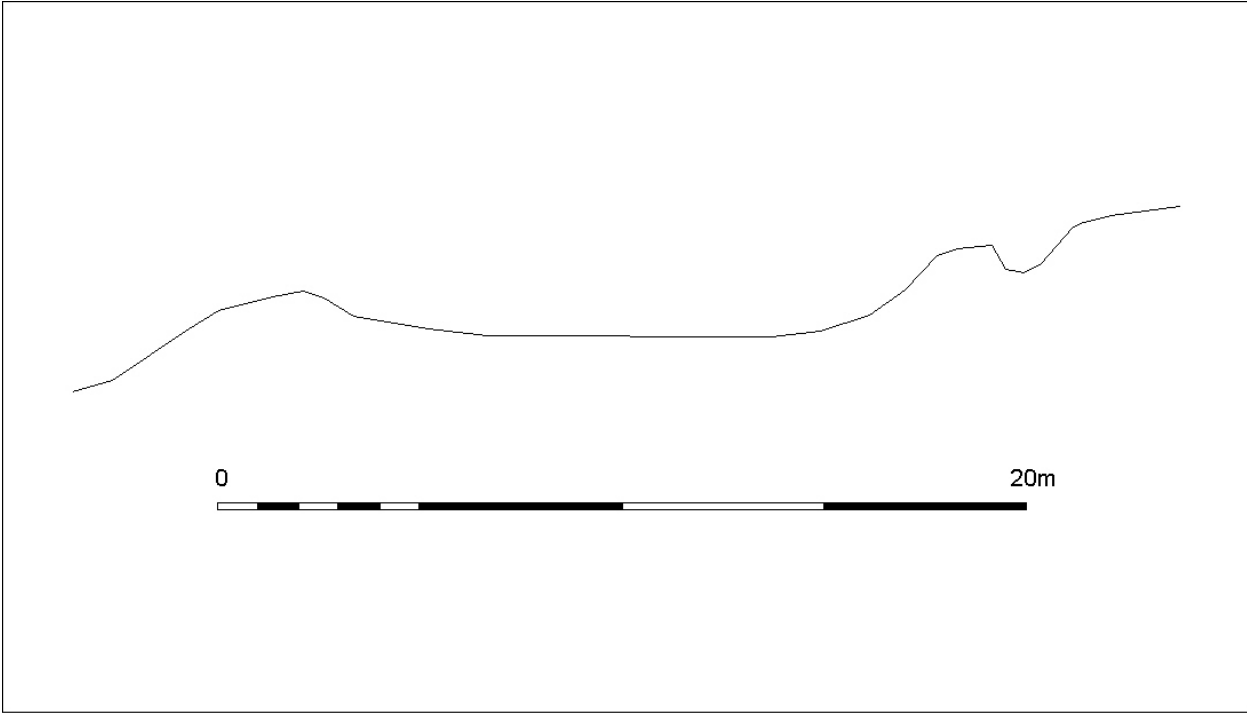
Fig. 8 Profile of reservoir PRN 80206

- 2.2 The largest reservoir (PRN 80206), which is now heavily silted, lies in an area of woodland close to the western boundary of the Reserve. The reservoir, which is c. 80m long and 20m wide, is formed by a substantial bank up to 4m wide and 2.5m high along the west side and south end, with a bank 2.5m wide and 1.2m high along the eastern side. Stonework is visible in the area of the outlet sluice at the north-west corner, with a short length of feeder leat (PRN 80204) leading to the south-east corner and another running from the outlet sluice northwards.
